NASA CR-114814

APOLLO RCS POSITIVE EXPULSION TANKAGE  
PRODUCT IMPROVEMENT PROGRAM  
FINAL REPORT - TASK F

INTEGRATION AND VERIFICATION  
OF SOLUTIONS

Bell Report No. 8514-928007

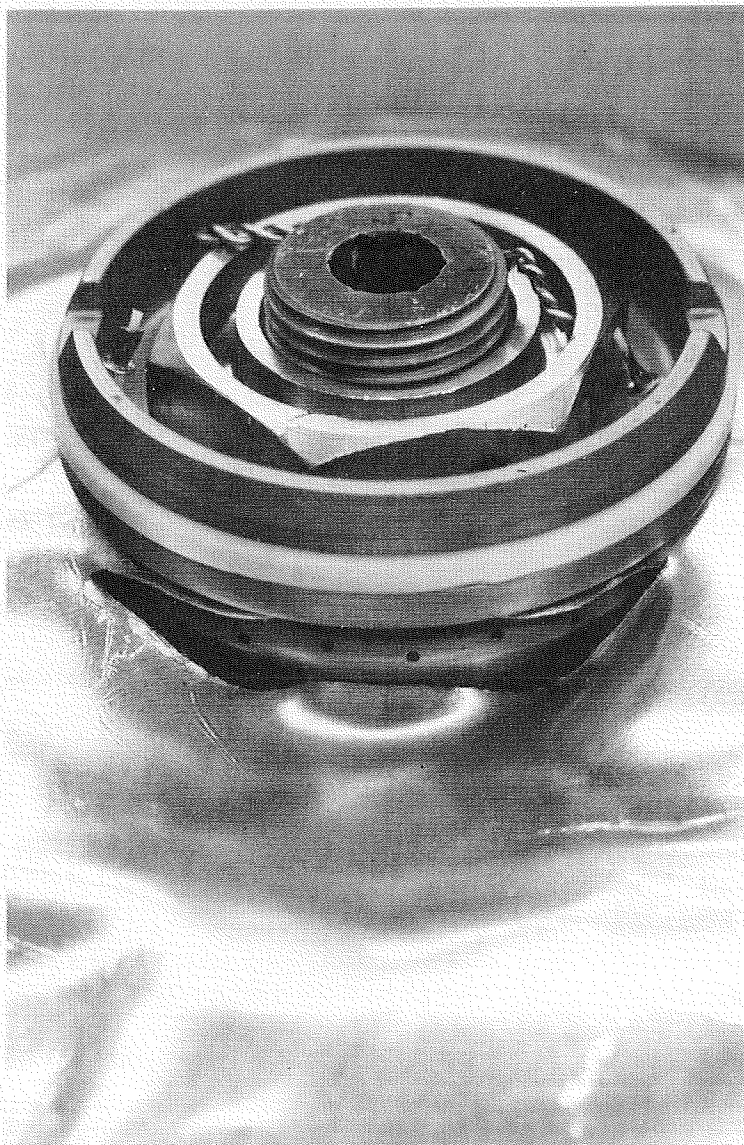
FIGURE 6. BLADDER S/N 69-1 FAILURE

The tank assembly was drained, purged, and disassembled. A peripheral slit, approximately 2 inches long, was found at the top of the bladder at the edge of the retainer washer. This slit was in line with the Z axis which was the direction of excitation. A highly stressed area was found at the edge of the retainer washer directly opposite the slit. (Refer to Figure 6 for photograph of bladder failure.) As can be seen in Figure 7, the remainder of the bladder was in excellent condition.

During the analysis of the failure in Bladder S/N 69-1, several modes of failure were eliminated immediately. There was no evidence of mechanical damage or material defect. The failure characteristics observable in a microtome cross-section were of a nature that could not result from puncture or other mechanical damage or from laminate defects. (See Figure 8.)

The foregoing evidence led to the conclusion that the previously described overtest (shock impulse) was responsible for the failure of Bladder S/N 69-1.

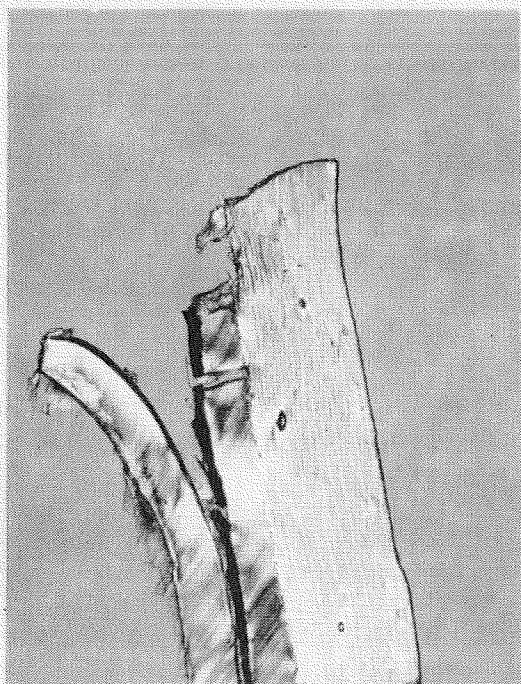
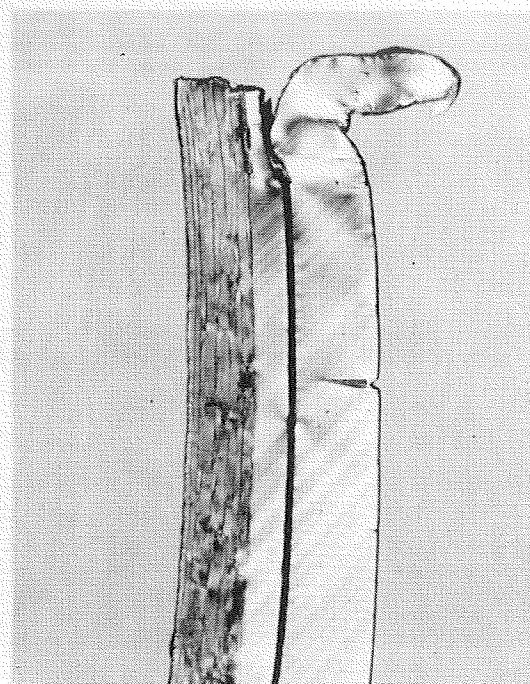
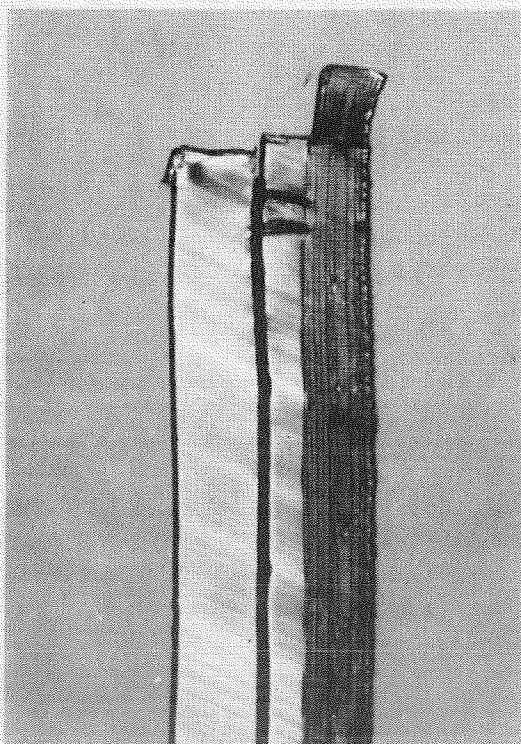
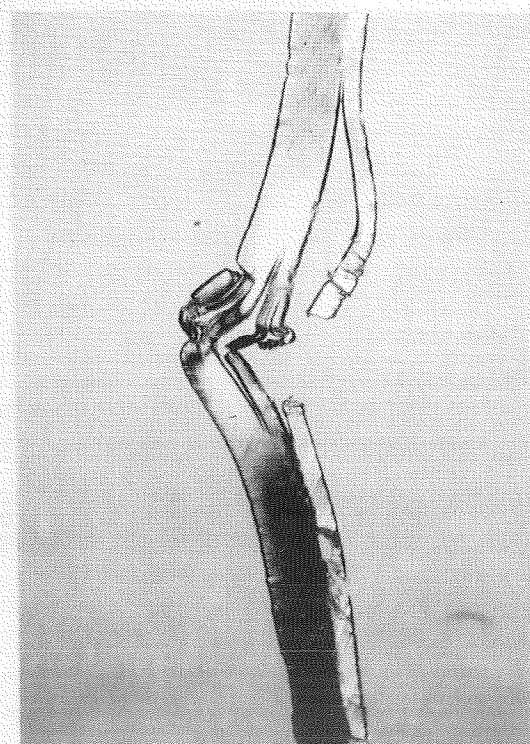
FIGURE 8. BLADDER S/N 69-1 AND 68-1 FAILURE CROSS-SECTION

Rolling of a buckled fold (vibration fatigue damage) can be eliminated from consideration by studying the characteristics of the failure at the bladder surfaces and through the cross-section. There was no rolling fold valley or localized depression leading into or paralleling the failure at any point. There were no striations or white ridges present.

These features always accompany rolling fold damage to Teflon. Rolling fold action of sufficient duration to cause a total rupture invariably elongates or distorts the codispersion layer. (Refer to Figure 8.) The edges of the codispersion layer of the S/N 69-1 failure were even and abrupt and showed no elongation or deformation. (See Figure 8.) The S/N 69-1 failure was reproduced in the laboratory by subjecting specimens to repetitive flexing (100,000 cycles) followed by a sudden shock sufficient to rupture the codispersion layer. As can be seen in Figure 8, the mode of failure of the laboratory shock specimens was very similar to that of Bladder S/N 69-1.

As can be seen in Figure 8, the failure appearance of Bladder S/N 68-1 was essentially identical to that of Bladder S/N 69-1. As previously discussed, this type of failure was duplicated by laboratory tests of bladder specimens which consisted of subjecting specimens to repetitive flexing followed by a shock-type load.

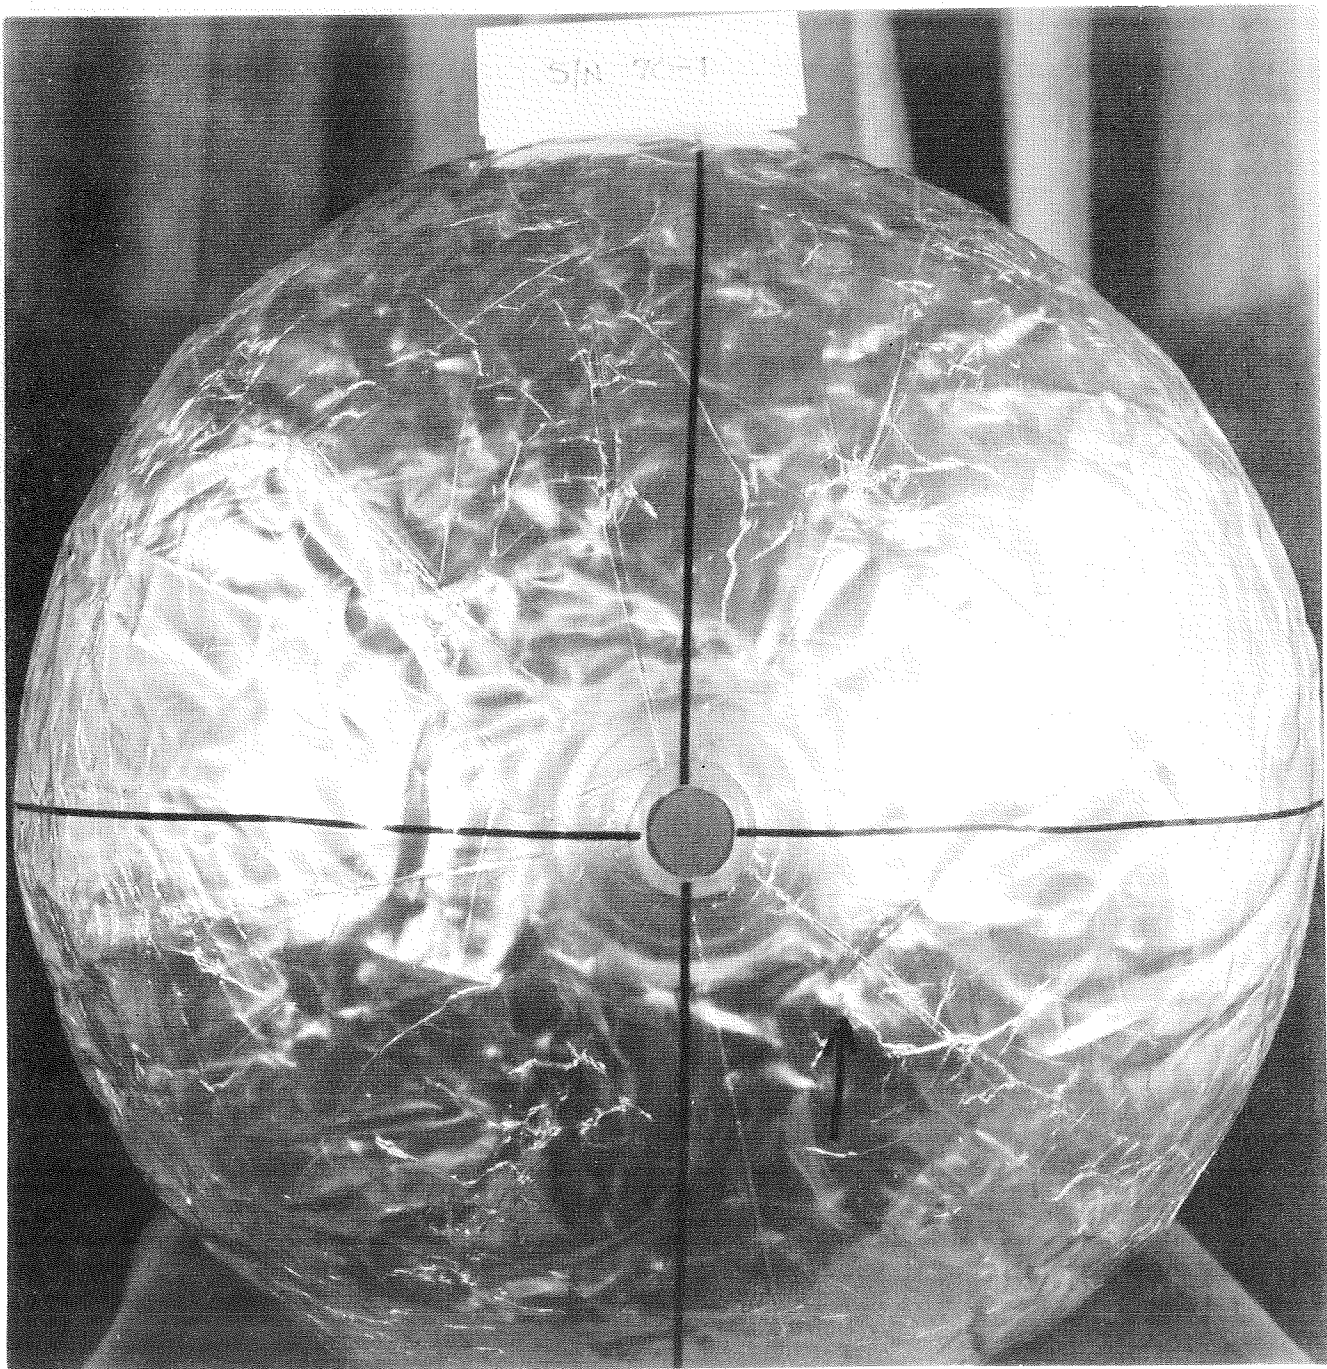
FIGURE 9. BLADDER S/N 70-1 FAILURE

The bladder assembly was removed from the tank for evaluation and the bladder was found to have a 0.007-inch-long rupture located in the retainer hemisphere 1.75 inches from the top of the bladder. (See Figure 9.) The failure was adjacent to an area which exhibited noticeable damage to the FEP laminate located on the outer side of the foil. The inner (codispersion) side showed only a ridge which contained the rupture. Other damage to the bladder was minimal as shown in Figure 10.

The above observations led to the conclusion that the rupture of bladder S/N 70-1 was not a fatigue-type caused by vibration testing. Rather, it appeared to be caused by a mechanism involving a single cycle (or very few cycles) which involved reversal of stresses in the film such as the draining, purging, and bladder expansion at the conclusion of the Z-axis vibration.

Since it is known that such a mechanism can cause failure in Teflon bladder material at low temperatures, the test logs were reviewed to determine whether a low-temperature condition accompanied by bladder motion due to internal pressure could have occurred during post-test bladder servicing. The results of this review, together with laboratory simulation tests, indicated that such a condition could have easily existed due to vaporization of trapped pockets of Freon-TF in the relatively stiff bladder folds which could have lowered the bladder temperature to as low as 20°F. Since no indication of bladder failure was observed during the Z-axis vibration test, or after venting the pressure following the test, it was concluded that the failure must have occurred after the post-test bladder draining, and most probably during the purging.

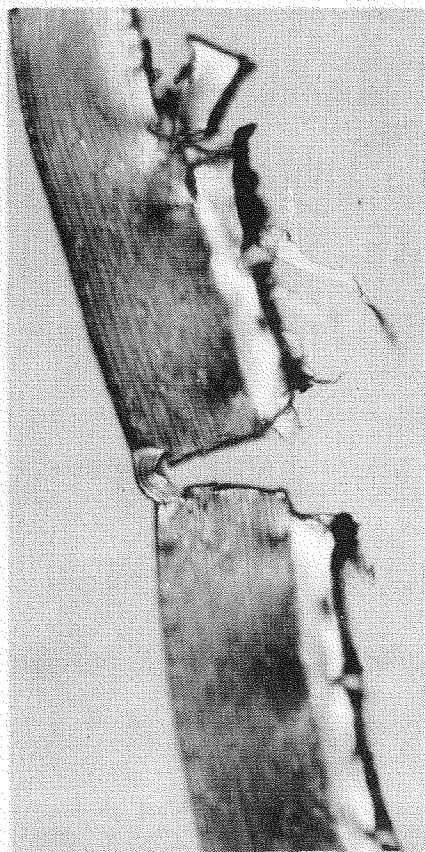
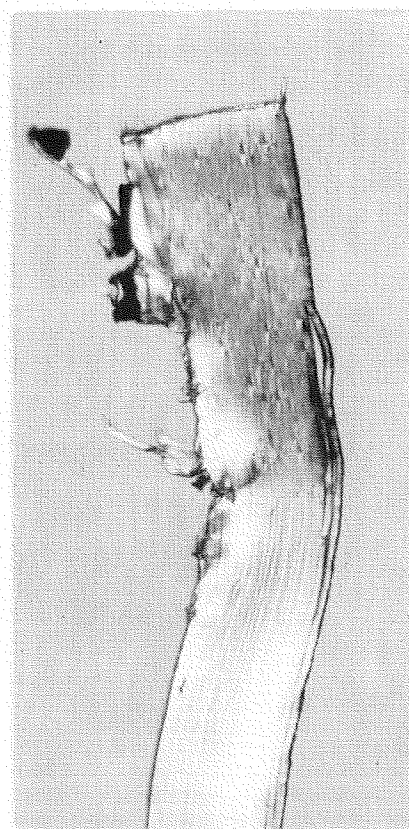
FIGURE 11. BLADDER S/N 70-1 FAILURE CROSS-SECTION

The failure area was removed from the bladder and examined microscopically with the following observations (see Figure 11):

a. The rupture was adjacent to an area which had been somewhat damaged by rolling of buckled fold action as evidenced by some buckling and necking down of the codispersion layer. (See Figure 11B.)

b. Although the failure occurred in the vicinity of an area which displayed some fatigue damage due to vibration, the failure area itself did not exhibit the normal evidence of fatigue due to repetitive folding. For example, Figure 11A does not show the reduction in area (necking down) exhibited in the adjacent area shown in Figure 11B.

c. The failure had the typical characteristics of a brittle failure. The rupture of the codispersion was abrupt with no reduction in thickness and no observable birefringence which would indicate residual stresses when studied under polarized light.

d. The FEP laminate at the point of rupture was broken with very little or no delamination, indicating a lack of repetitive damaging action.

e. A microscopic study of the cross-sectional profile of the rupture revealed that the failure occurred when the outside surface of the bladder in the failure area was placed in tension. This study also indicated that the sub-laminates of the codispersion layer had been slightly distorted inward prior to failure.

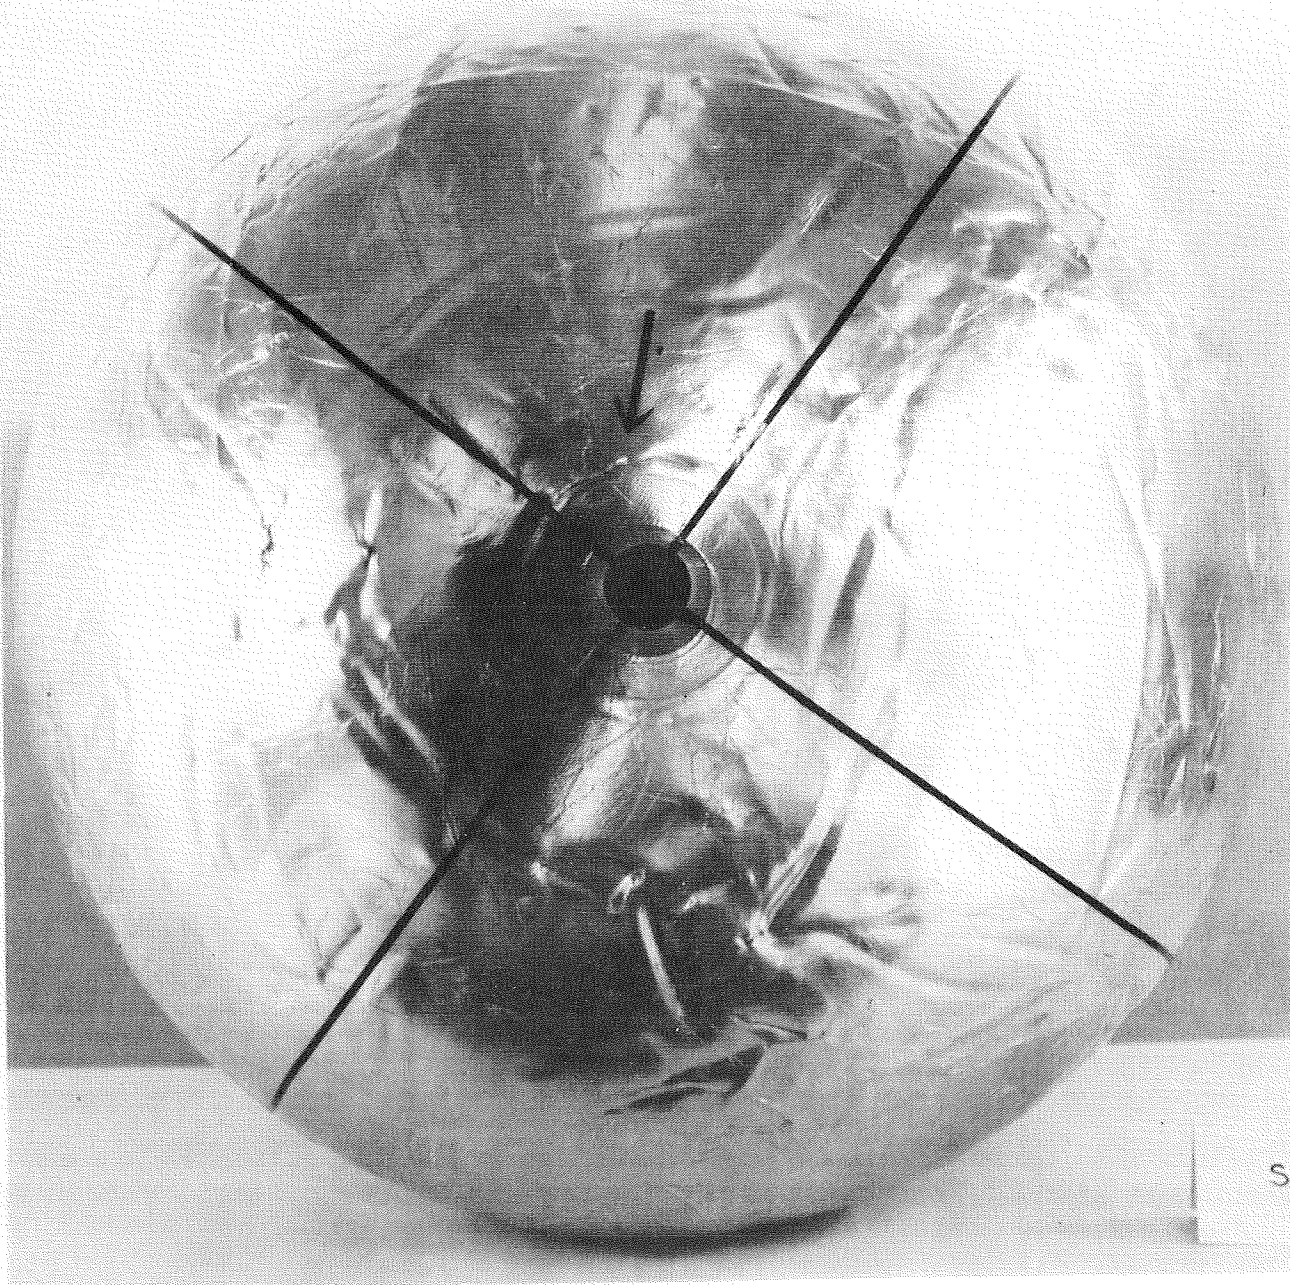
FIGURE 12. BLADDER S/N 68-1 FAILURE

The tank assembly was disassembled and a slit approximately 1 inch long was found at the top of the bladder at the edge of the retainer washer. (See Figure 12.) This slit was in line with the Z axis and closely approximated the Bladder S/N 69-1 failure. With the exception of the failure itself, very little damage had occurred to the bladder or the foil laminate. Figure 13 shows the bladder with interior lighting to highlight damage to the foil laminate.

The exact cause of the Bladder S/N 68-1 failure is unknown. However, because the failure characteristics are identical to that of Bladder S/N 69-1, it appears that the abnormally high response levels during the Z-axis random vibration were responsible for the bladder failure.

B. The failures experienced during the vibration testing reported herein were due to bladder stiffness and could be avoided by use of a thinner film construction and/or a change in the attachment of the bladder ends to the diffuser tube.

Since the undersized bladder with aluminum foil laminate has been shown to be a valid design for Apollo-type teflon bladders, it is recommended that further studies be conducted to overcome the design problem at the bladder-to-diffuser interface. This problem could be solved by lessening the bladder stiffness and by altering the design of the diffuser/bladder interface itself.

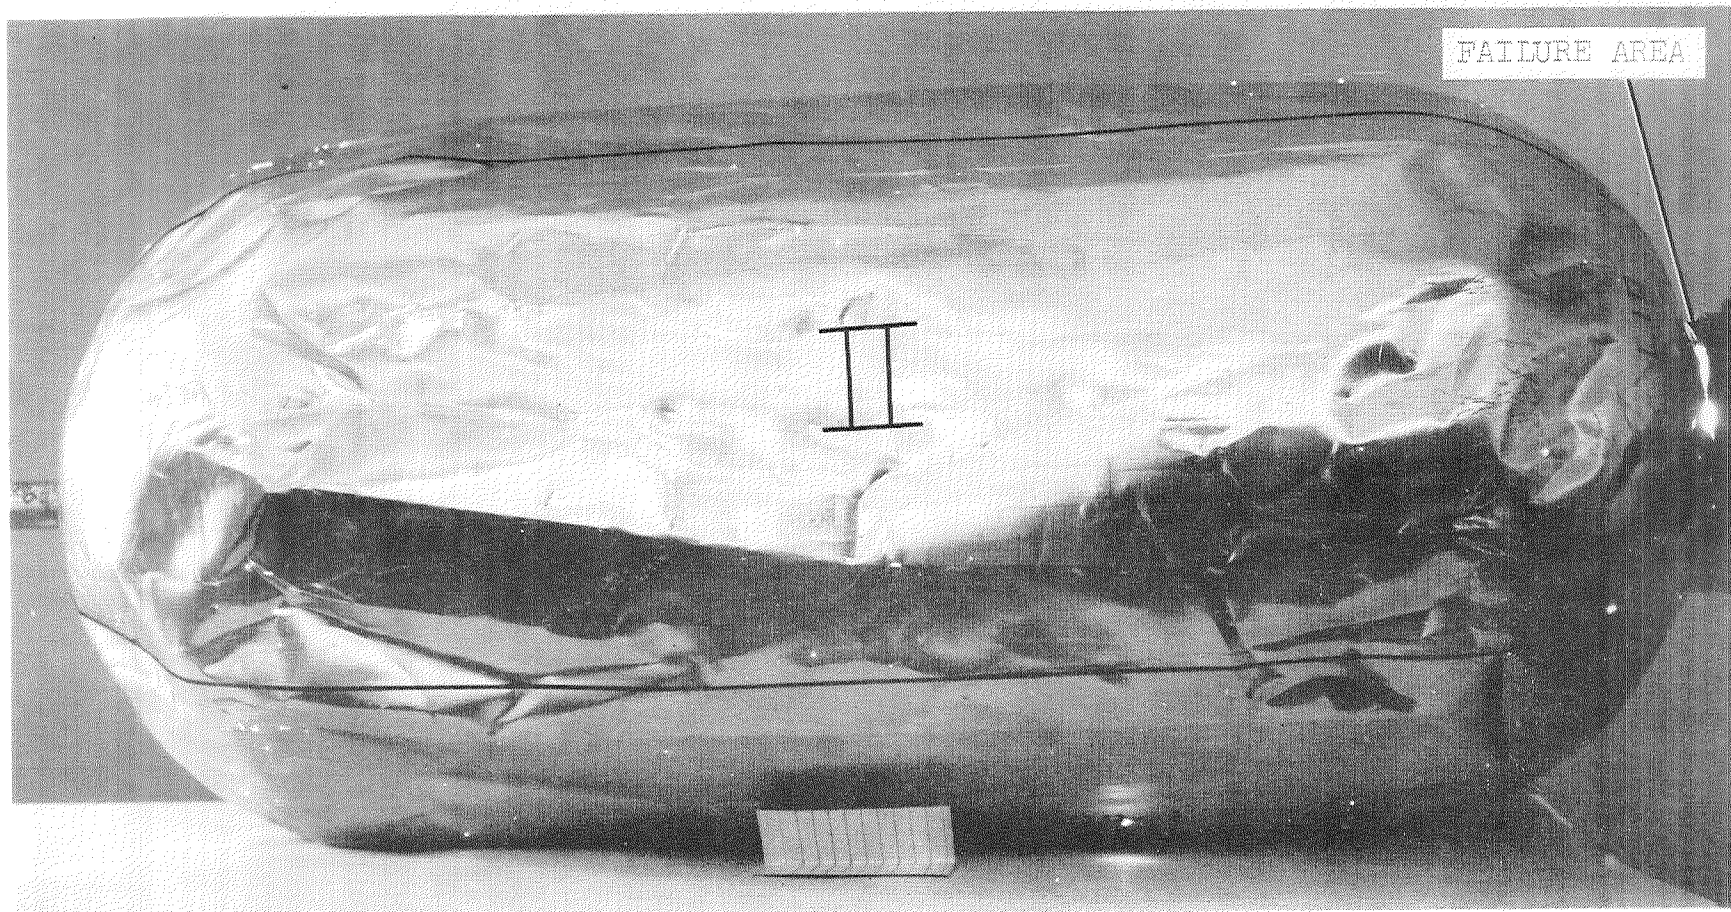
FIGURE 13. BLADDER S/N 68-1 POST-VIBRATION CONDITION  
(WITH INTERIOR LIGHTING)

As shown in Table 1, bladder S/N 68-1 gave strong evidence that the amount of vibration experienced in a normal launch/boost dynamic environment would do effectively no damage to an aluminum foil permeation barrier in a teflon bladder. The 0.1 scc/15 minutes leakage measured after 5 minutes of random vibration in the longitudinal axis is approximately 0.1% of the average actual bladder leakage rate experienced during acceptance testing of Apollo SMO tanks delivered as flight hardware.
